Preliminary report

Crash involving Malaysia Airlines Boeing 777-200 flight MH17

Hrabove, Ukraine - 17 July 2014

The Hague, September 2014

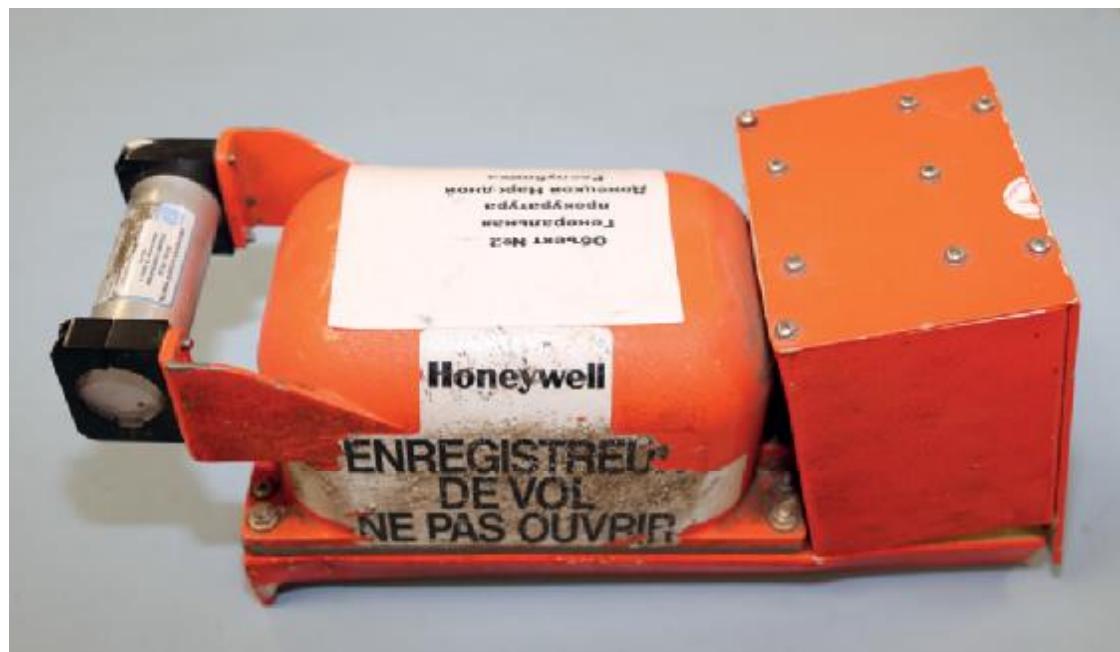
The housing of the CVR (figure 4) had been damaged and, although the model and serial numbers were unreadable on the data plate, the serial number 1366 - matching the one provided by Malaysia Airlines - was found stamped on the underside of the chassis. The external damage found on the CVR is consistent with impact damage, the internal memory module was intact. The recording capacity of this recorder is 30 minutes.

The full 30 minutes were successfully downloaded and contained valid data from the flight.

Figure 4: Cockpit voice recorder. (Source: AAIB)

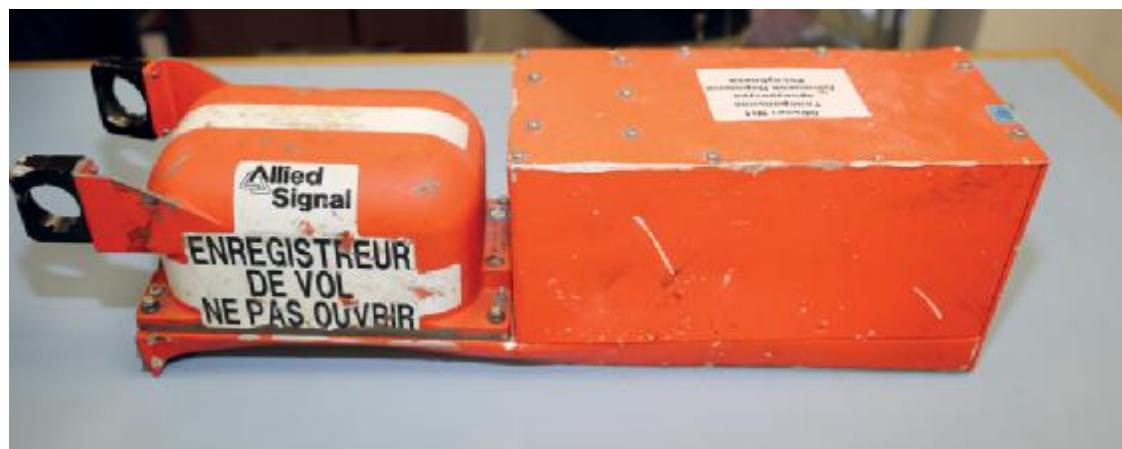
The label on the housing of the FDR (figure 5) showed that it was Allied Signal Model Number 980-4700-003 with Serial Number 2196. These details matched the details provided by Malaysia Airlines. The recorder was found damaged but the internal memory module was intact. The external damage found on the FDR was consistent with impact damage. The FDR, which can record 25 hours of operational data, was successfully downloaded and contained valid data from the occurrence flight.

Figure 5: Flight data recorder. (Source: AAIB)

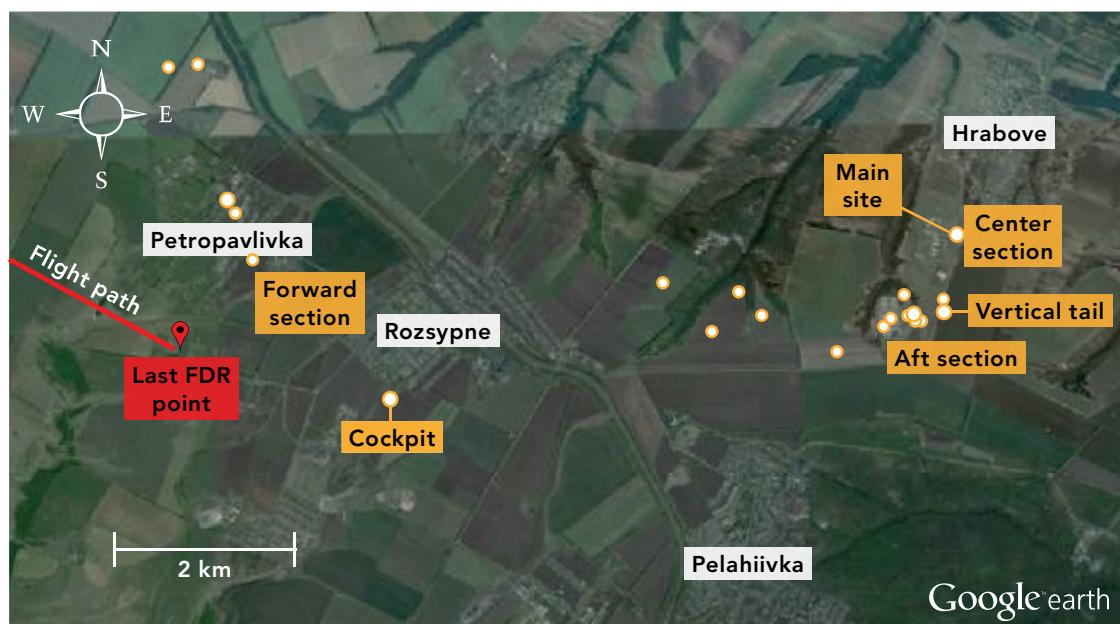
The aircraft wreckage, identified from the on-site photographs and satellite images, consisted of many large and small pieces distributed over an area of approximately 10 km by 5 km (figure 6). Fuselage pieces, cargo and baggage were scattered throughout the wreckage site. There were many additional unidentified pieces that are not shown in the figure. For easy reference the wreckage site has been divided into sections as shown in figure 6. These sections match with the aircraft sections shown in figure 7.

Figure 6: The last location of the aircraft in flight taken from the FDR. Wreckage distribution is grouped per section of the aircraft (Source: Google Earth, wreckage information Dutch Safety Board).

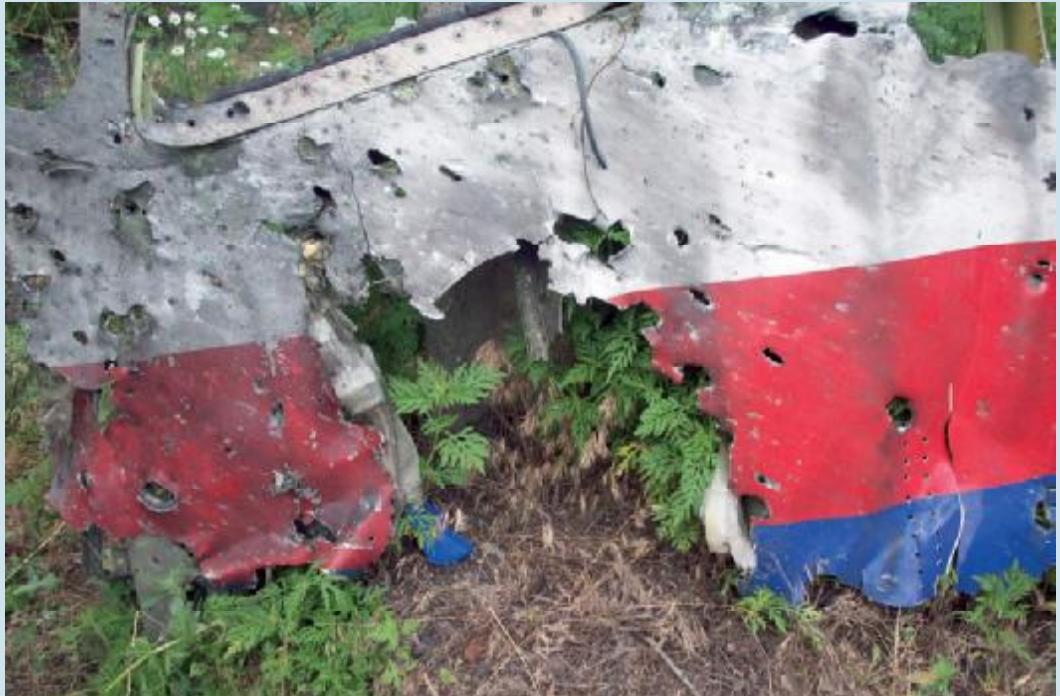
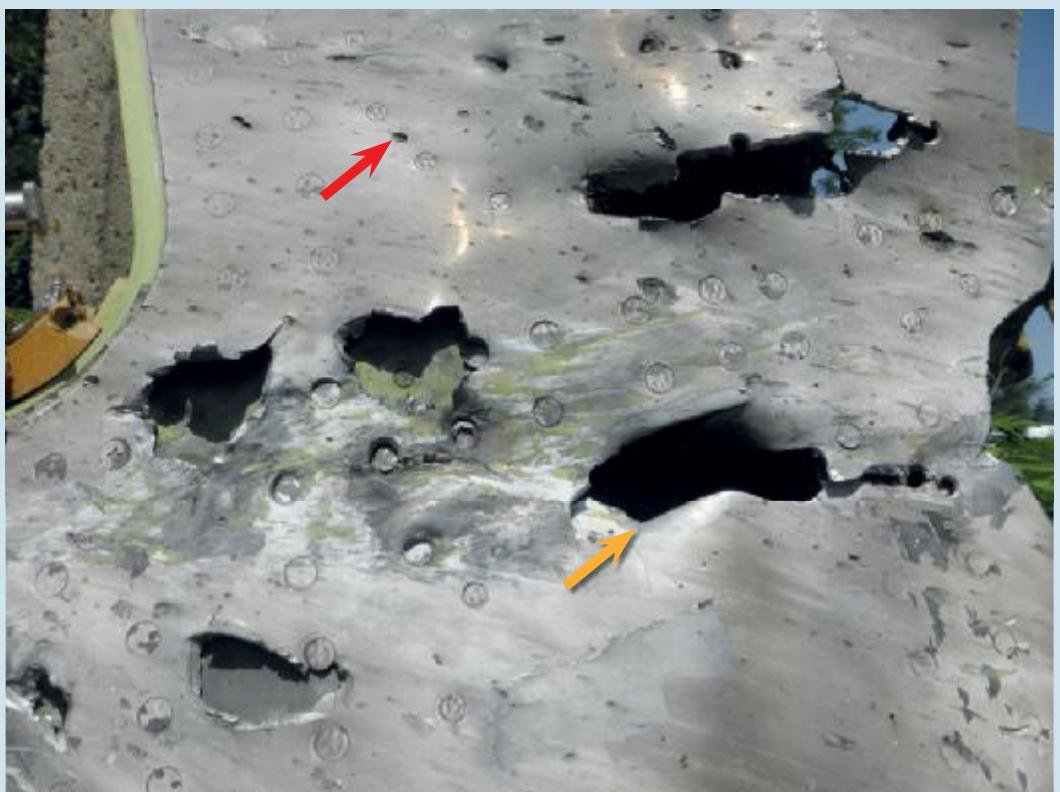
Photographs from the some wreckage showed that a number of pieces contained multiple holes and indentations. An example of a piece of wreckage containing such damage was a piece of skin from below the left cockpit window (figure 8) found in the town of Petropavlivka.

Figure 8: Forward fuselage skin from below the left cockpit window containing numerous small holes and indentations (above); enlarged image of the right upper corner of this skin (below) showing puncture holes (orange arrow) and pitting (red arrow). (Source: DCA and AFP)

Noting that the investigation team has not yet had the opportunity to recover these components for forensic examination, photographs from the wreckage indicated that the material around the holes was deformed in a manner consistent with being punctured by high-energy objects. The characteristics of the material deformation around the puncture holes appear to indicate that the objects originated from outside the fuselage.

The pattern of damage observed in the forward fuselage and cockpit section of the aircraft was consistent with the damage that would be expected from a large number of high-energy objects that penetrated the aircraft from outside.

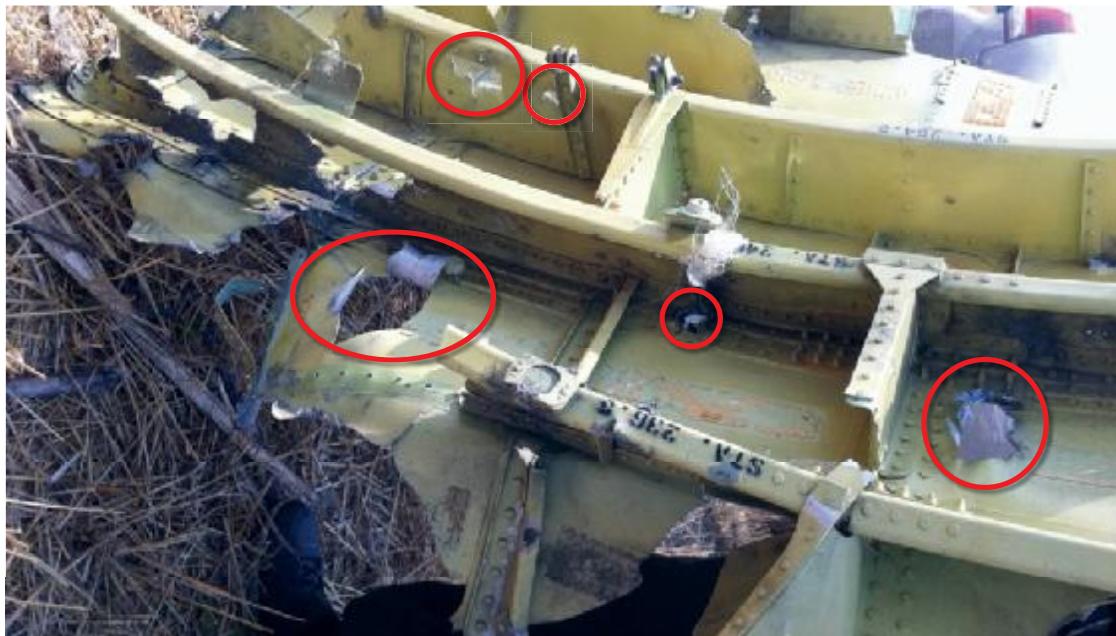
Around 1.7 km north of the position where the cockpit window structure was found, was a section of the cockpit roof also showing holes indicating penetration from outside (figure 9).

Figure 9: Part of the inside cockpit roof, indicating penetration with objects from outside. (Source: DCA)

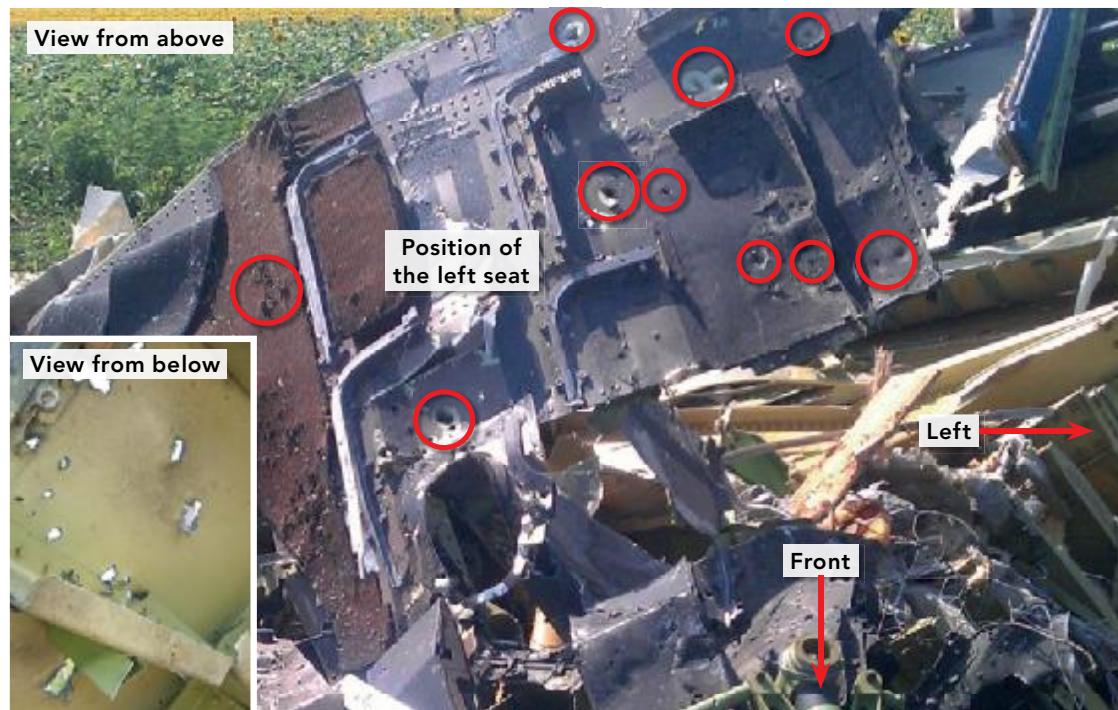
Puncture holes identified in images of the cockpit floor suggested that small objects entered from above the level of the cockpit floor (figure 10).

Figure 10: Cockpit floor with floor parts showing puncture holes (red circles) coming from above the floor.

Detailed examination of the structural damage is ongoing. Forensic examination will be performed if the wreckage can be recovered,

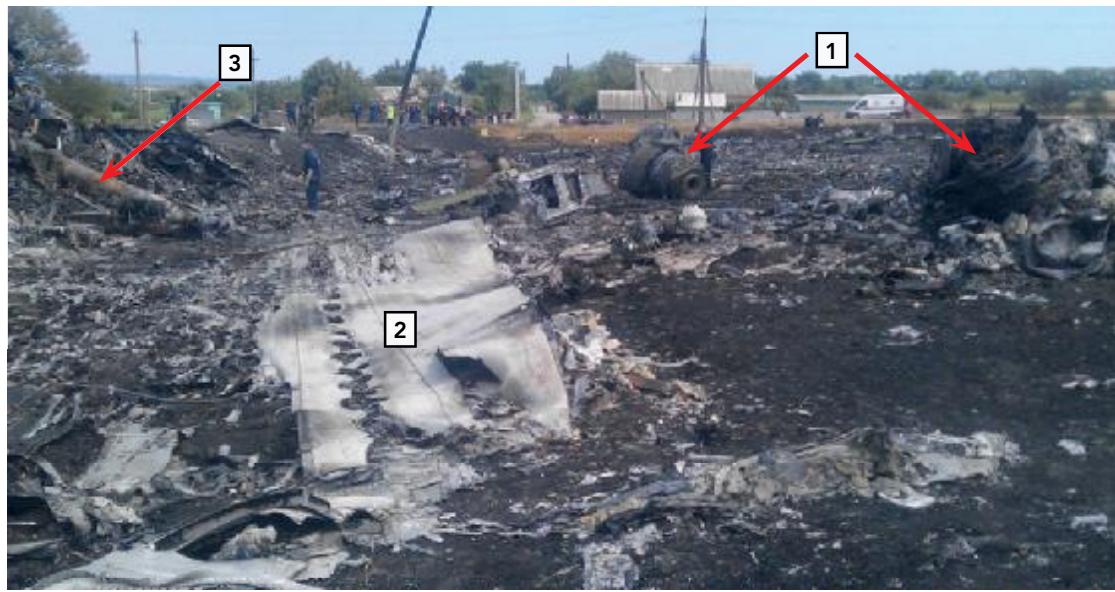
The main site was located at the south-western corner of the town of Hrabove, 8.5 km from the last recorded FDR position of the aircraft. This site contained parts of the wings, both engines, the main landing gear and a portion of the fuselage (figure 11). Aircraft parts distributed over the main site had been subjected to post crash fire.

Figure 11: Main wreckage site showing engine parts (1), wing with inspection hatches (2) and main landing gear (3). (Source: NAAI)

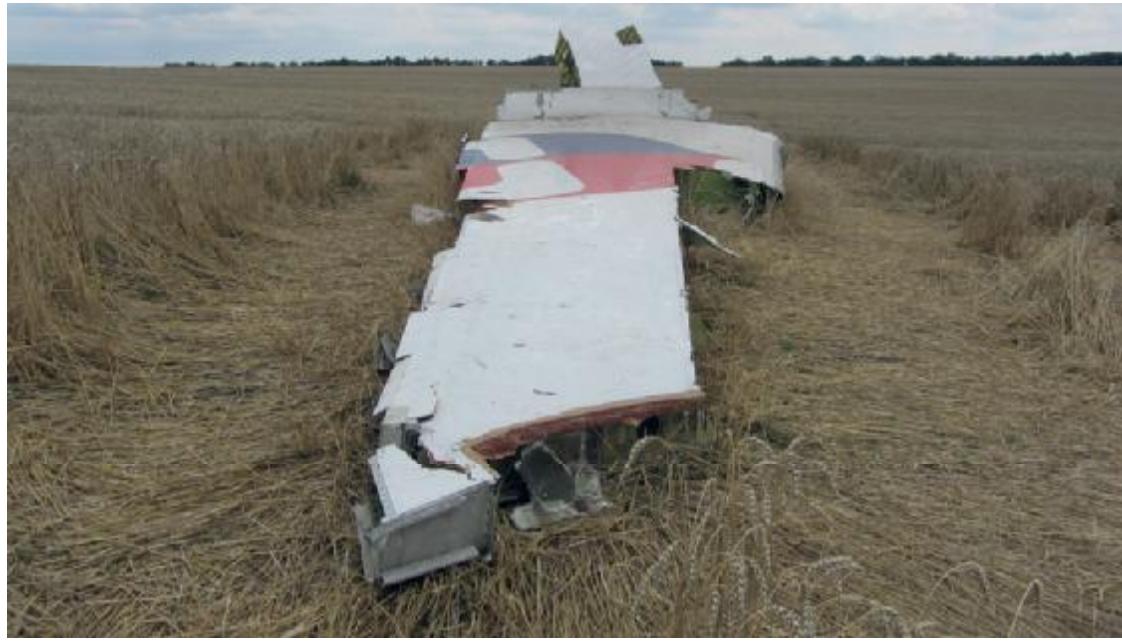
The vertical tail (figure 12) was located in a field to the south of Hrabove, approximately 8 km from the last recorded FDR position. The vertical tail was still attached to a portion of the upper rear fuselage. The rudder and a portion of the vertical tail's leading edge were not attached. The remains of the rear fuselage, horizontal stabiliser centre section, and items from the cabin were found about 100 metres north of the vertical tail.

Figure 12: Vertical tail. (Source: DCA)

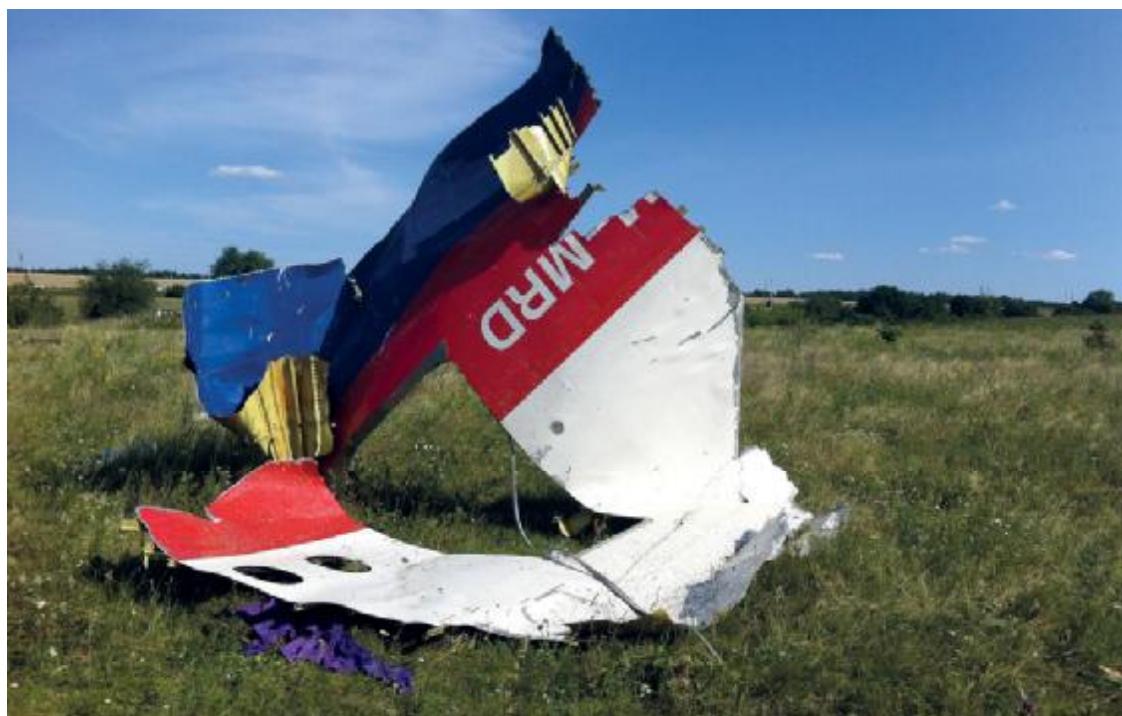
A section of aft fuselage skin from the right side (figure 13) was located 330 metres west of the vertical tail, and the left wing tip and right horizontal stabilizer were also in this location. The left horizontal stabilizer was found another 330 metres to the west.

Figure 13: Aft fuselage skin, right side, with partial registration of the aircraft. (Source: NBAAI)
