Preliminary report

Crash involving Malaysia Airlines Boeing 777-200 flight MH17

Hrabove, Ukraine - 17 July 2014

The Hague, September 2014

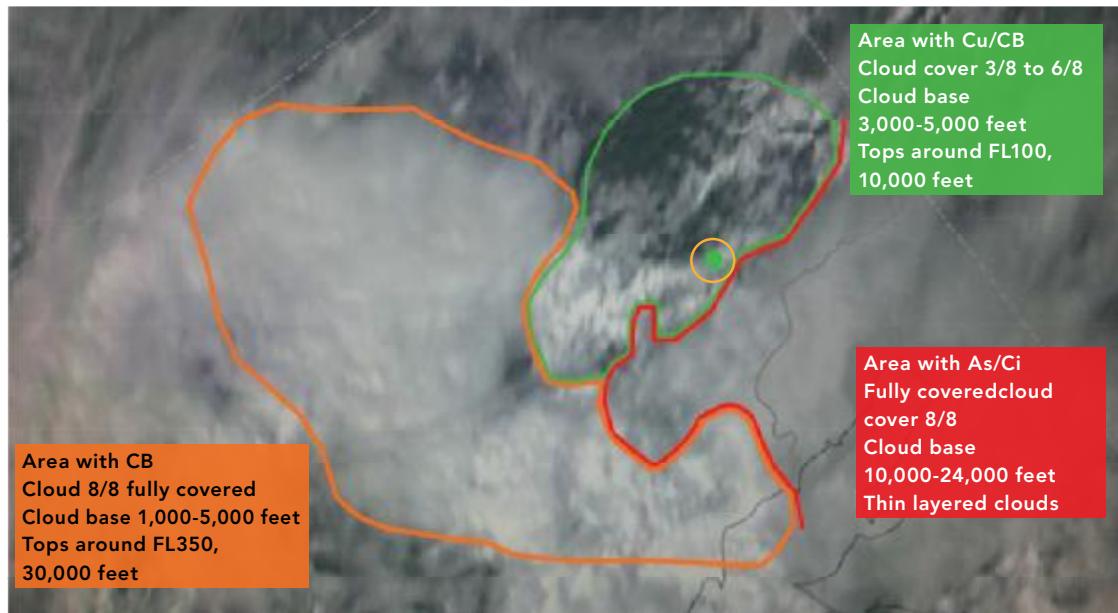
The orange area contains mainly Cumulonimbus clouds (rainclouds). The cloud coverage is mostly 8/8. The cloud base is around 3,000 to 5,000 feet, with the tops of the clouds reaching FL350 (35,000 feet).

Figure 3: Cloud coverage for 17 July at 12.00 hrs.¹⁰ The circled green dot indicates the last position of aircraft.

The orange area south-west of the accident location contains mostly Cumulonimbus clouds with possible thundershowers. (Source: KNMI)
